Case Study

Indoor and Outdoor Spectrum Co-existence
Real world operational experience

5.0 Menstrie Sky Q Service Disruption

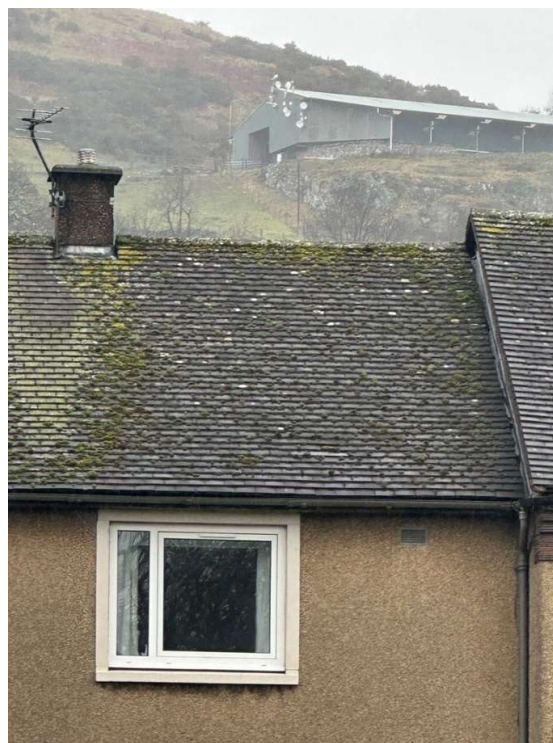
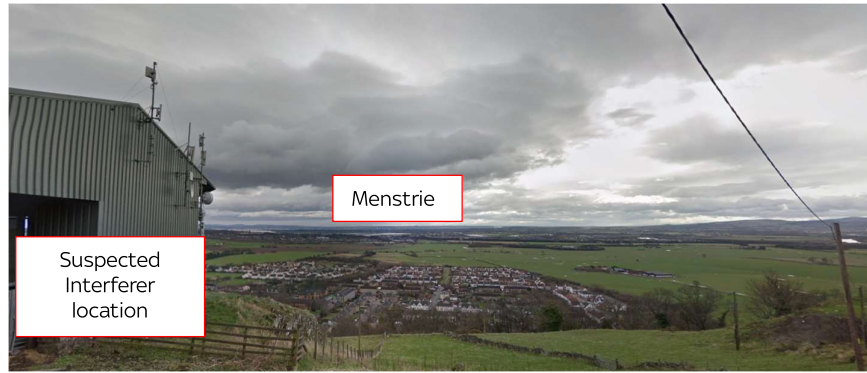
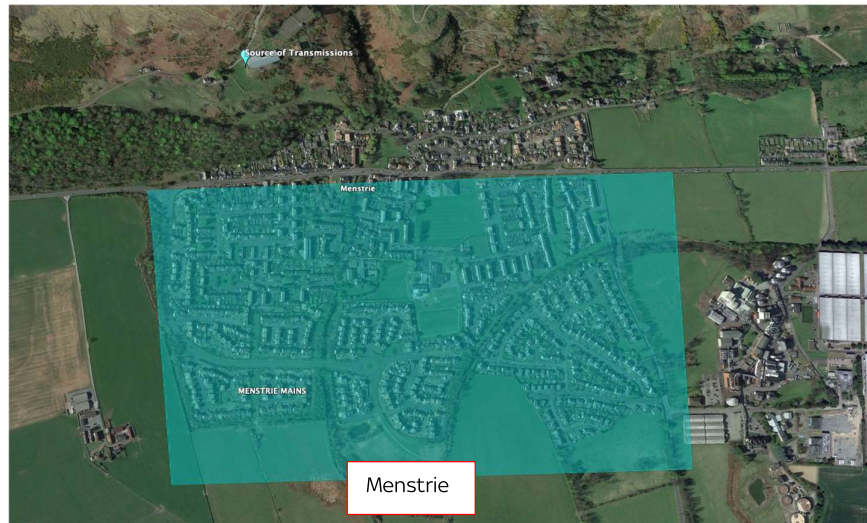
Although the potential site of the node appeared to make itself obvious, triangulation with a directional antenna and signal strength analysis were employed to locate the site.

Data gathered by the field engineering team was collated and submitted to Ofcom’s Spectrum Investigation Team and a formal case opened on 14th March for a breach of IR2030 by operating a fixed outdoor service within the 5150- 5250 MHz frequency band. A request was made to Ofcom to expedite the investigation due to the number of customers affected. This was noted.
